# An Improvised Two-Dimensional Laser Surface Scanner for Diagnosis of Rf Thermionic Electron Gun Problems

William G Jansma, Engineering Specialist  
Advanced Photon Source  
Argonne National Laboratory

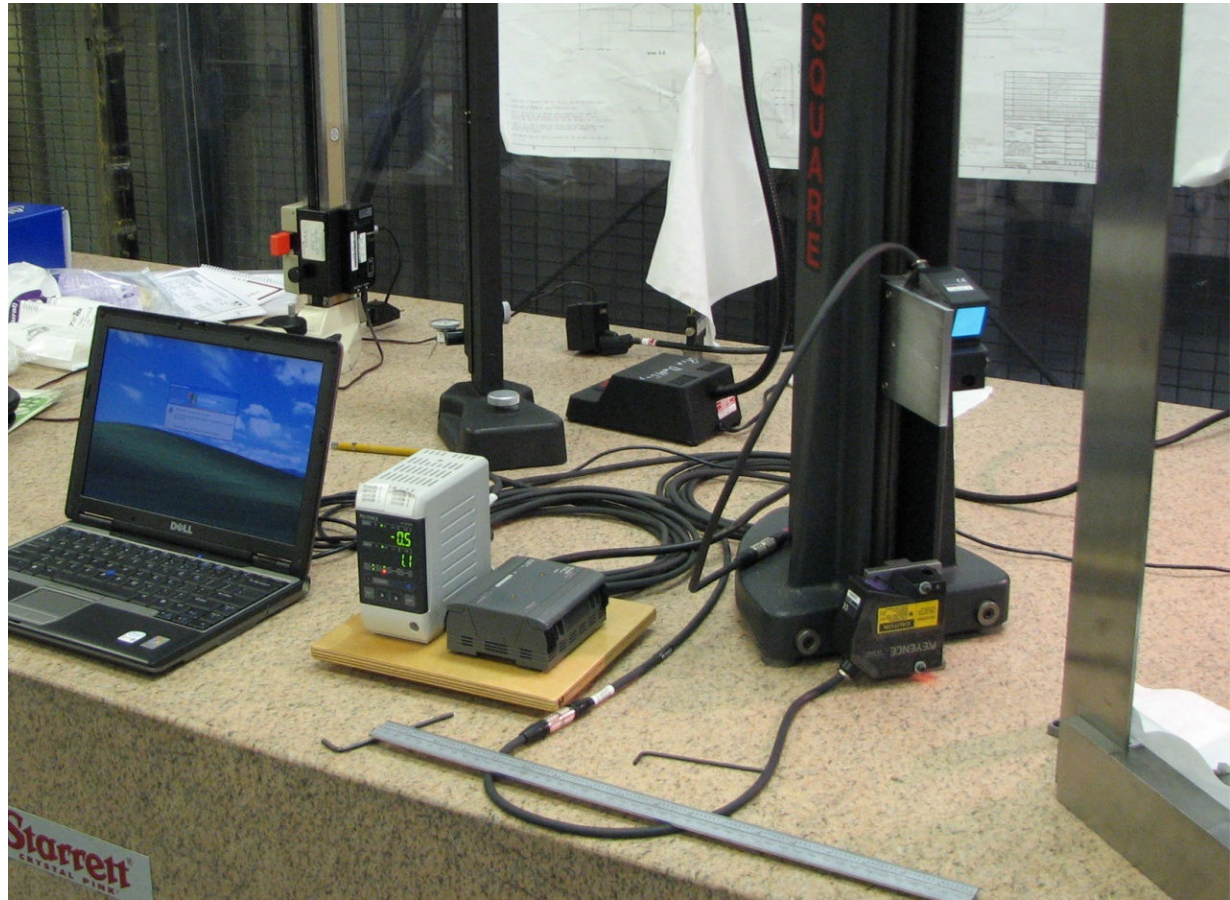
- Initially a LK-G157 sensor head was mounted vertically to the translation, but the return signal was blocked when the laser spot was transitioned over steps in the surface. The problem was solved by horizontally mounting the sensor head to the translation.
- The LK-G 157 sensor head projects a 1.7-mm-wide laser spot, recording an average profile over the width of the laser spot. To improve accuracy a LK-G 152 sensor head that projects a 120 micron diameter laser spot was mounted to the translation, allowing a much thinner measurement “slice” to be recorded.

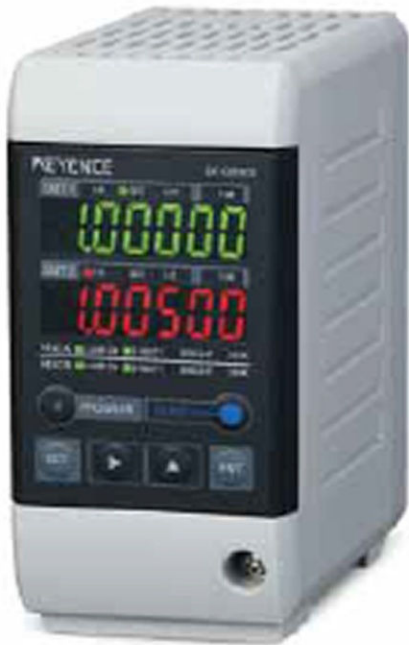
- Data collection was accomplished using the LK-G3001 controller and laptop with LK-Navigator freeware.
- Data was saved as a .csv text file that opens as a single column in a spreadsheet that is cut and pasted into a coordinate worksheet.
- Synchronous controller output allowed the columns to be pasted side by side in the worksheet forming coordinates.
- Coordinates for each azimuth scan were adjusted to fit a common centerline and plotted over each other to produce an abstract 3-D view in a 2-D graph.

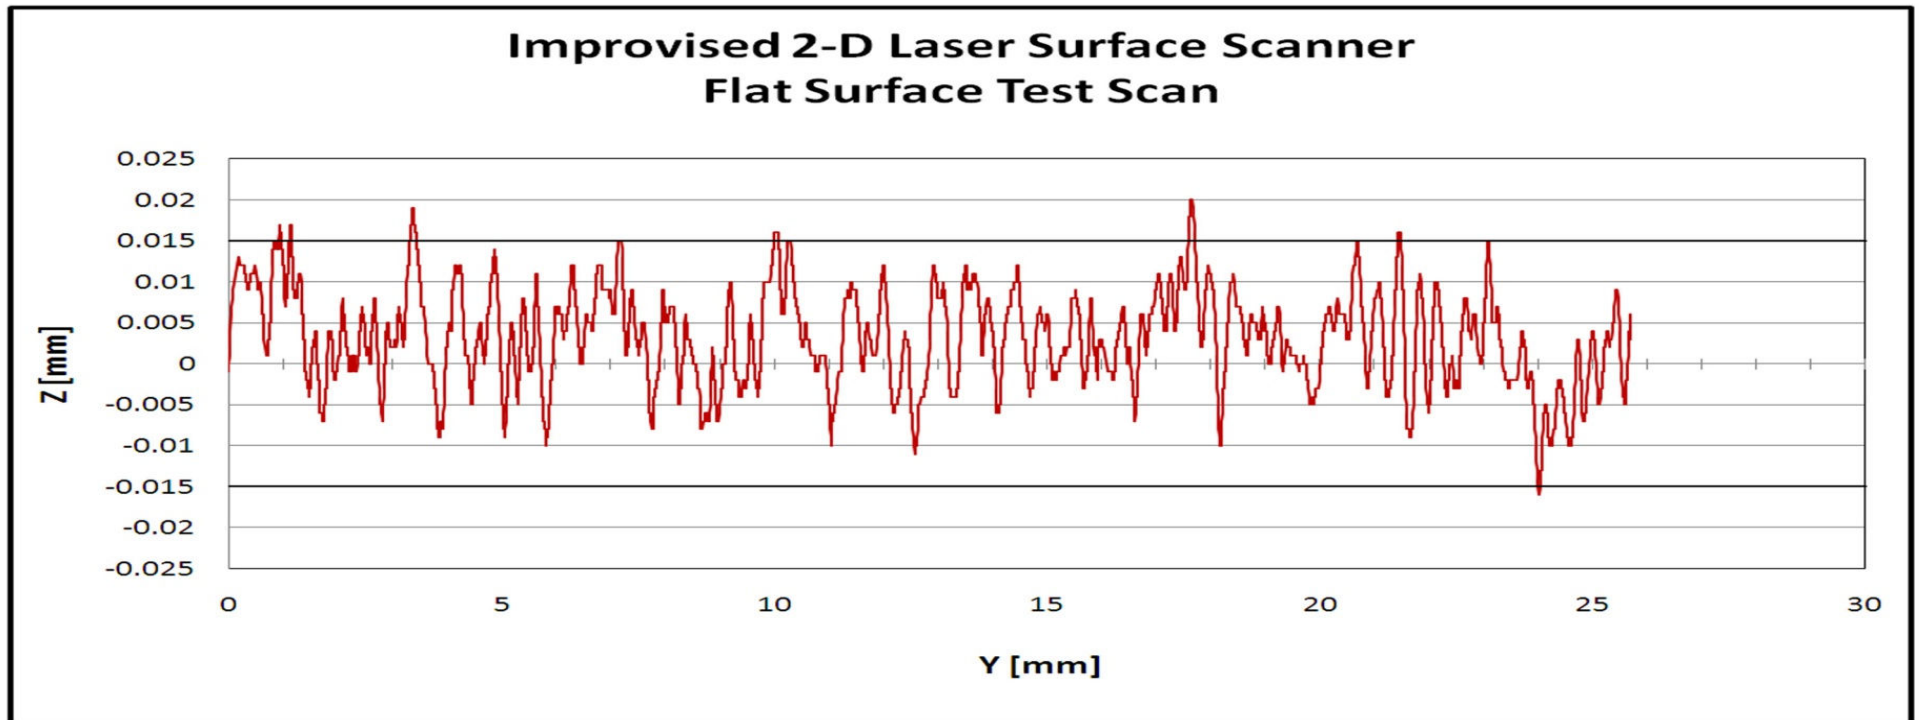
- Accuracy initially estimated to be +/- 5 microns, taking into account the sensor resolution of 0.5 microns, translation accuracy of 2.5 microns over 500 mm, and the typical scan translation of only 25 mm.
- Further analysis indicates the accuracy of measurements taken with the improvised system to be closer to +/- 15 microns.
- Decrease from the initial estimate is attributed to noise produced by the motion of the sensor head during translation.
- Accuracy might be improved through refinements in motion control for the translation.

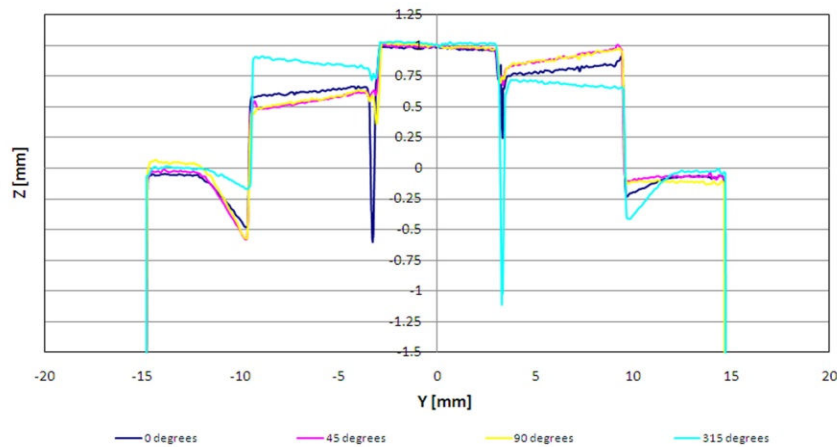
## Cathode Cartridge Distortion

- Distortion was caused by over-tightening of eight #4-40 screws that secure the cartridge within the gun body. Damage was inadvertent, as no drawings or procedure were available.
- Source of problem was discovered, but what now?

- Plots of the profile scans taken with the improvised 2-D laser scanner revealed distortion of the mating surfaces of both the cathode cartridges and the rf gun bodies.
- The flat, planar mating surface is intended to seal the rf cavity from leakage and act as a thermal conductor. Arcing can result from rf energy leakage, and improper heat transfer affects thermal stability.
